Quality Assurance and Source Inspection

Contract #: 04-0120F4Cty: SF/ALA Rte: 80 PM: 13.2/13.9File #: 82.28**WELDING INSPECTION REPORT****Resident Engineer:**Siegenthaler, Peter**Address:** 333 Burma Road**City:** Oakland, CA 94607**Report No:** WIR-018443**Date Inspected:** 23-Nov-2010**Project Name:** SAS Superstructure**OSM Arrival Time:** 700**Prime Contractor:** American Bridge/Fluor Enterprises, a JV**OSM Departure Time:** 1530**Contractor:** Westmont Industries**Location:** Santa Fe Springs, CA.**CWI Name:** Ruben Dominguez**CWI Present:** Yes No**Inspected CWI report:** Yes No N/A**Rod Oven in Use:** Yes No N/A**Electrode to specification:** Yes No N/A**Weld Procedures Followed:** Yes No N/A**Qualified Welders:** Yes No N/A**Verified Joint Fit-up:** Yes No N/A**Approved Drawings:** Yes No N/A**Approved WPS:** Yes No N/A**Delayed / Cancelled:** Yes No N/A**Bridge No:** 34-0006**Component:** Travelers**Summary of Items Observed:**

SAS-EB Traveler**Fixed Stairs Section**

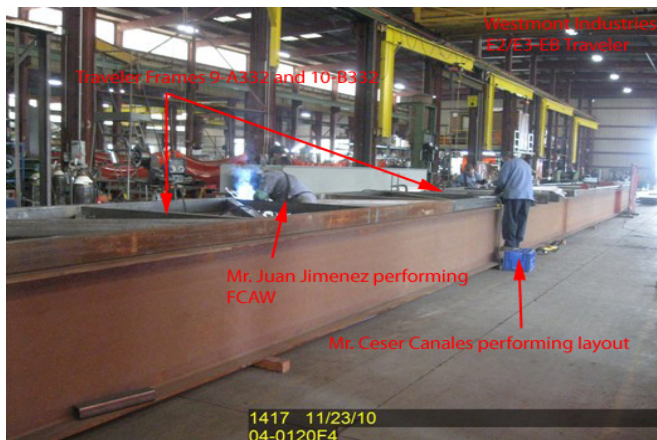
Inspector observed that the fitting and tacking activities were also being performed on what appeared to be various plate material fillet and flare groove welds. In addition, the QA Inspector observed Mr. Anaya and Mr. Canales performing fitting and tacking activities on the Platform Balcony Assembly, for the Lower Truss Section. The QA Inspector observed the activities being performed on channel and Tube Steel (TS) material.

See attached picture below.

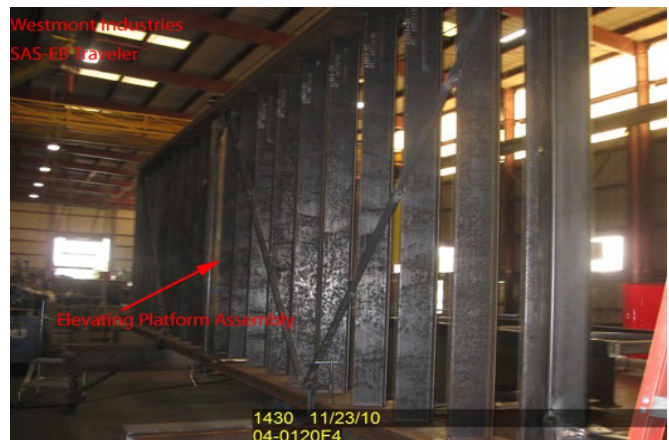
On this date, the QA Inspector observed WMI production welder Mr. Juan Jimenez (WID # 3059), continuing to perform Flux Core Arc Welding (FCAW) welding activities on the intermediate and diagonal bracing Tube Steel (TS) material. The QA Inspector observed that the FCAW being performed by Mr. Jimenez appeared to be for the Frame Assembly identified as 9-A332 and 10-B332, per the shop drawings. The QA Inspector observed that the weld joints appeared to be designated as 6mm fillet and flush flare groove welds and that Mr. Jimenez was performing the FCAW in the flat (1G) and vertical (3F) positions, throughout the shift. In addition to the activities being performed by Mr. Jimenez, the QA Inspector observed WMI Production fitter Mr. Cesar Canales, performing layout and fitting activities on tube steel material, for the above mentioned Frame Assemblies. The QA Inspector observed that Mr. Canales was performing the activities on the intermediate and diagonal bracing for the Frame Assemblies, prior to tack welding.

See attached picture below.
